# Robbins Farm History Project

# Robbins Farm History Project Proposal

## Design Drawings

Sept 2014

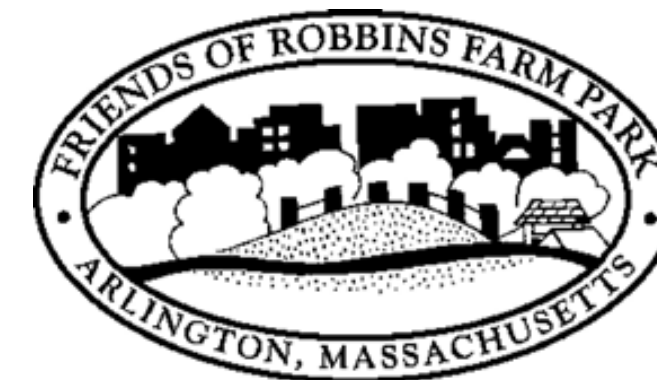
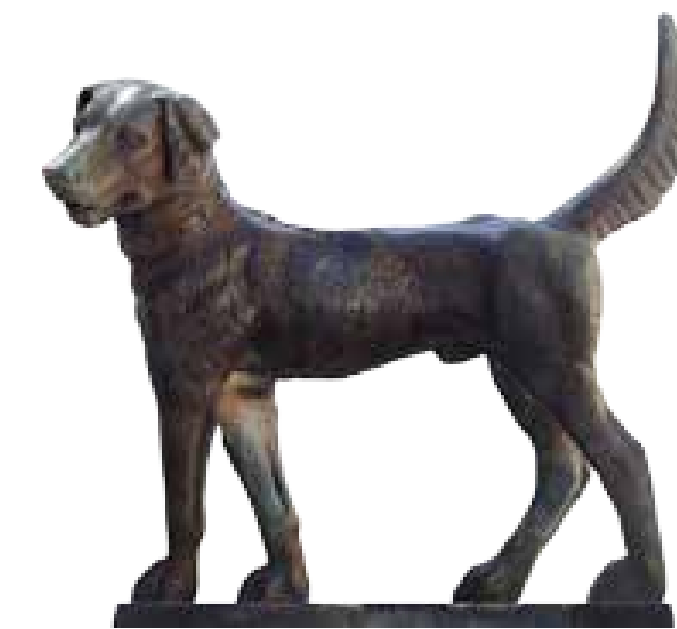
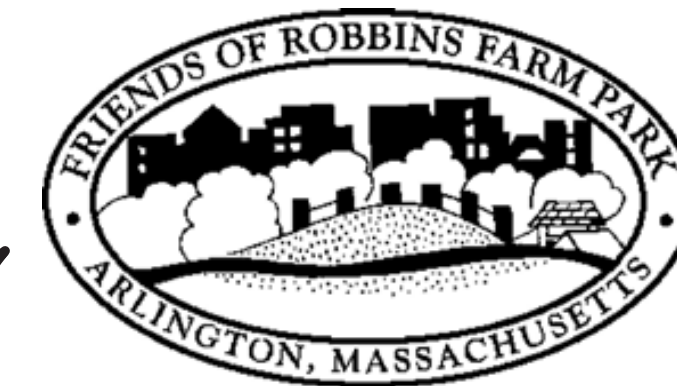
## 7 STATUE AREA DETAIL SECTION

BRONZE DOG STATUE WITH BRONZE BASE  
(By Betz Art Foundry, Houston, TX)  
Concealed Vandalproof Mounting on  
on Concrete Base Structure as Required

1" CHAMFERED EDGE  
At Top of All 4 Sides of Concrete Base

BLACK CONCRETE STAIN SEALER  
On Top 6" Min Portions  
of Concrete Structure

CONCRETE STATUE SUPPORT BASE  
Structure as Required

APPROXIMATE EXISTING GRADE  
Modify Existing Grade as Required  
For Level Area On All Sides of Statue

COORDINATE STATUE MOUNTING DETAIL  
Connection to Concrete Structure Below (e.g. Stainless Steel  
Threaded Rods Set in Epoxy in On-Site Drilled Holes As Shown)  
Coordinate Clearance with Concrete Reinforcement As Required

BRONZE DOG STATUE  
WITH BRONZE BASE  
(By Betz Art Foundry, Houston, TX)  
Vandalproof Mounting on  
on Concrete Base Structure as Required

CONCRETE BASE STRUCTURE  
Below Statue Base  
With Chamfered Top Edge  
Exposed Above Ground Portion  
Stained with Black Concrete Sealer

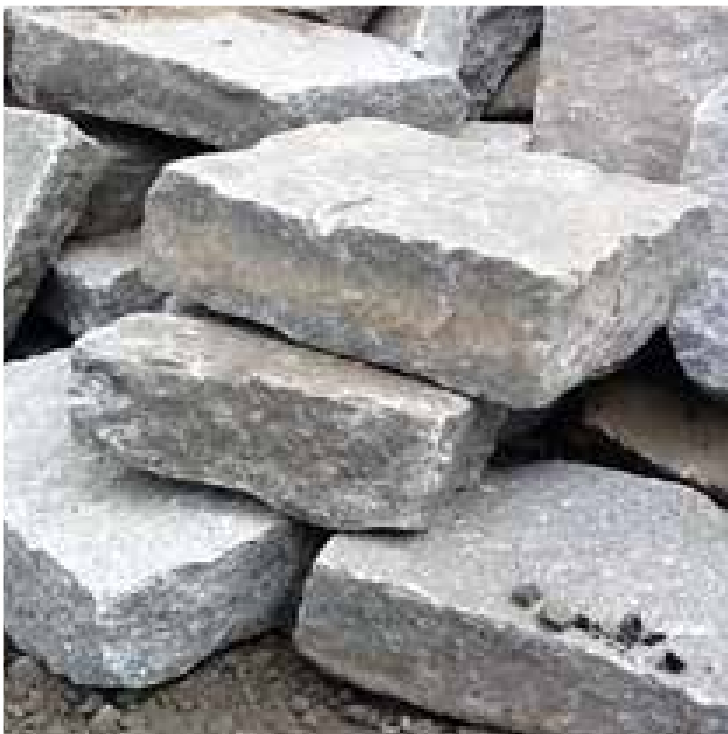
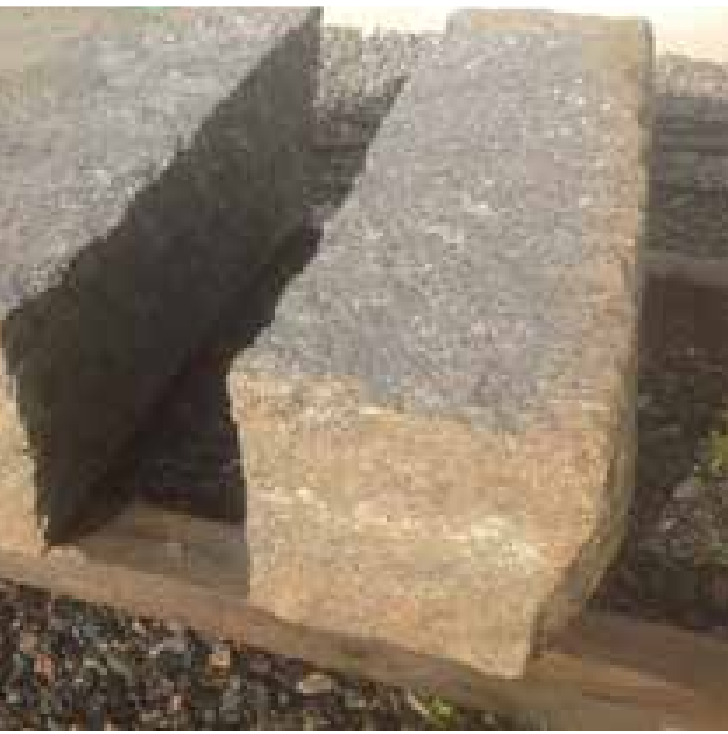
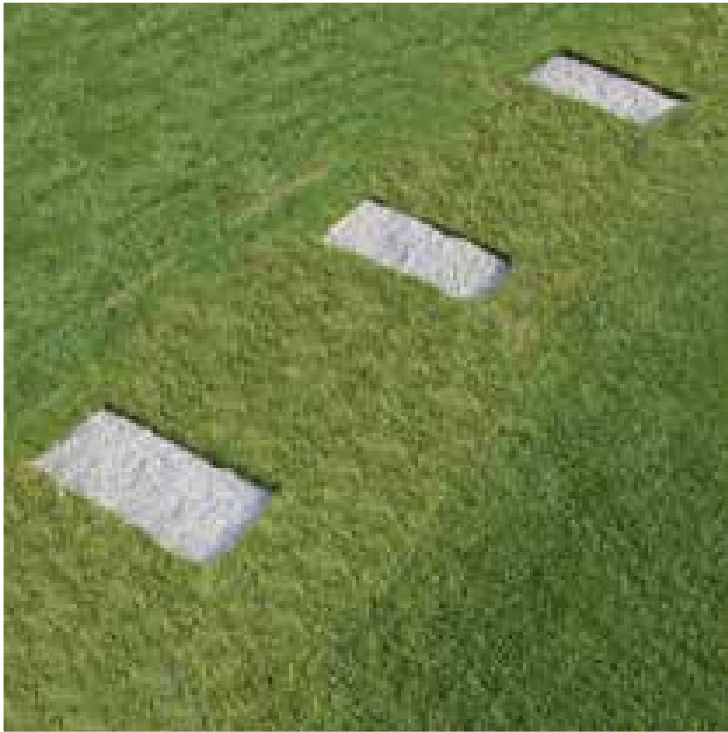
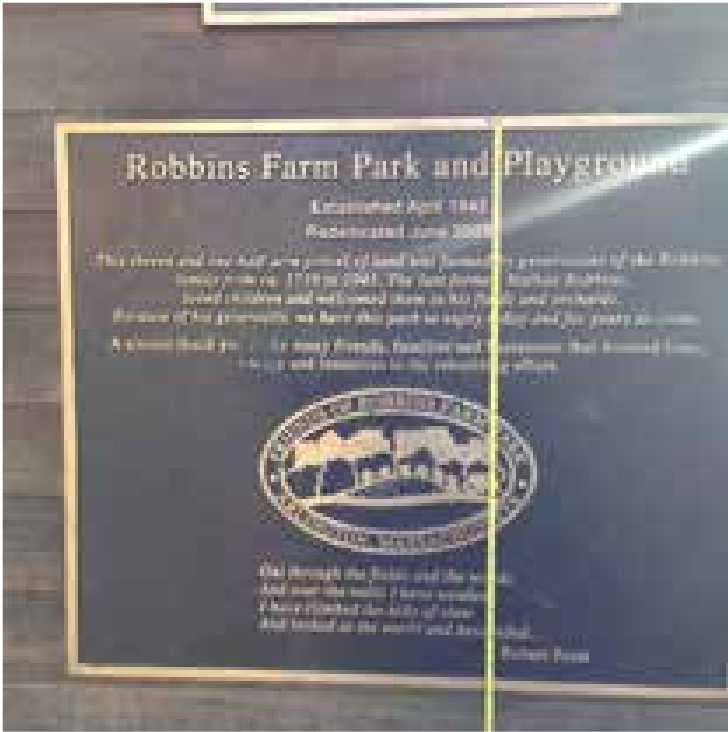
8 MATERIALS

Reclaimed Granite Pavers

Reclaimed Granite Blocks

Bronze Plaque with Bas Relief

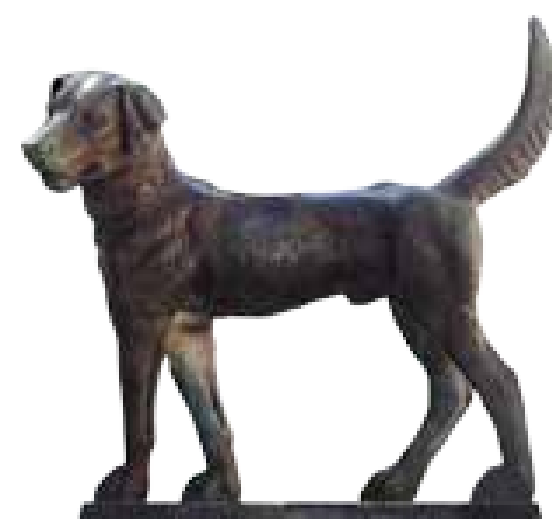
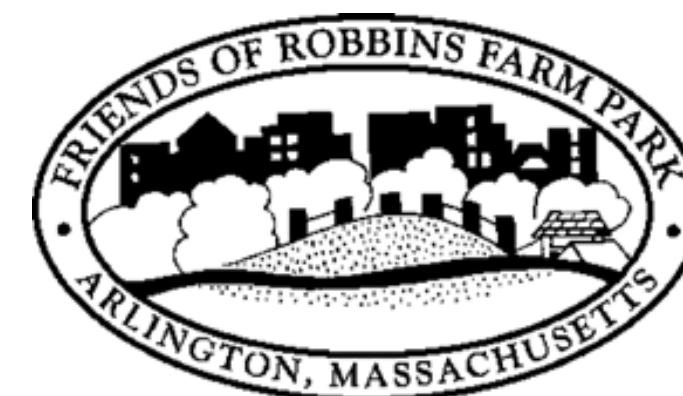
## 9 PLAQUE MARKER

BAS RELIEF ILLUSTRATION  
(From Vector Artwork)

CUSTOM BRASS PLAQUE  
Dark Field with "Leather" Texture  
Polished Bright Raised Art & Text  
Concealed & Vandalproof Mounting  
18" X 13 1/2"

RAISED BORDER EDGE FRAME  
3/4" Wide & Min 3/4" Deep

RAISED HAIRLINE BORDER  
(Can be provided as part of Vector Graphic)

RAISED LETTERING, TYP  
(Can be provided as part of Vector Graphic)
